# Manhole Inspection Summary

## Manhole # S37AA\_037MH

Insp Date: **11/19/08 1:34 PM**

**Location** Address: **401 e monument st**

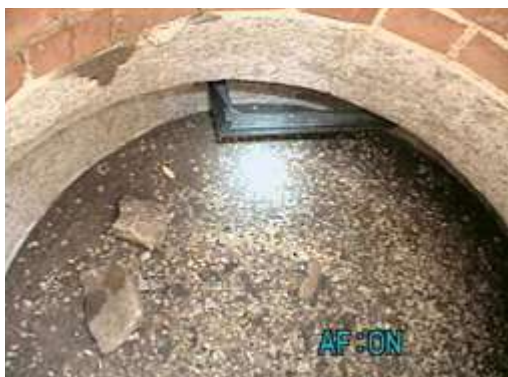
Defect 2

bench debris

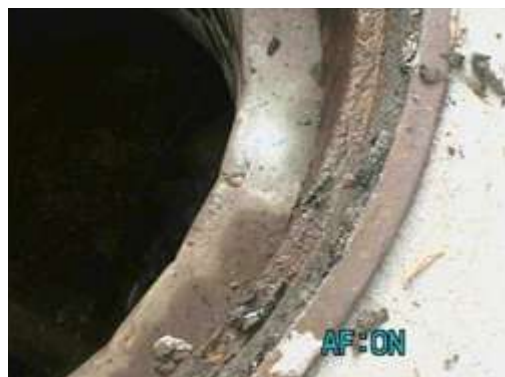
Defect 1

Offset: **3** (in.)

frame offset

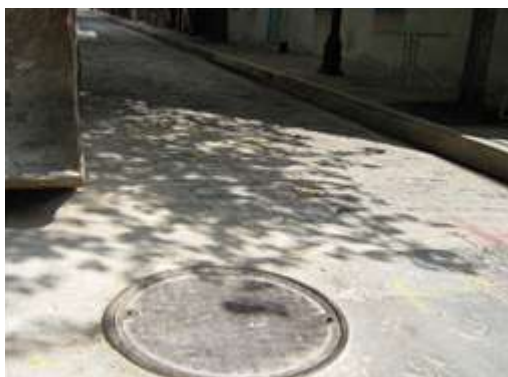
Defect 4

Diameter: **32** (in.) Length: **0** (in.) Dist A/B Grade: **1** (in.)

cover above pavement

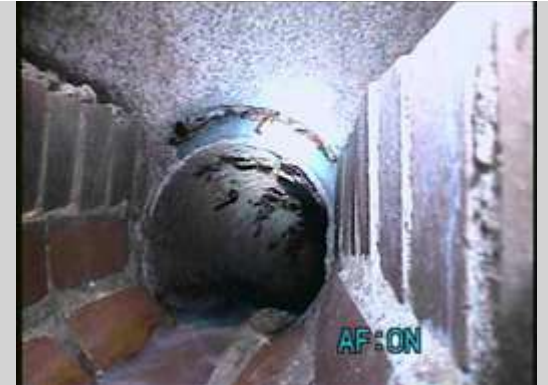
12 O'Clock Outflow

8 in. Circular Gravity Sewer  
Pipe Out @ 12 O'Clock

Pipe Material: **Clay** ☐ Pipe Lined

Invert Depth: 5.30 (ft.) Flow Characteristics: **Fast**

Infiltration: **None** Pipe Seal Cond: **Unknown**

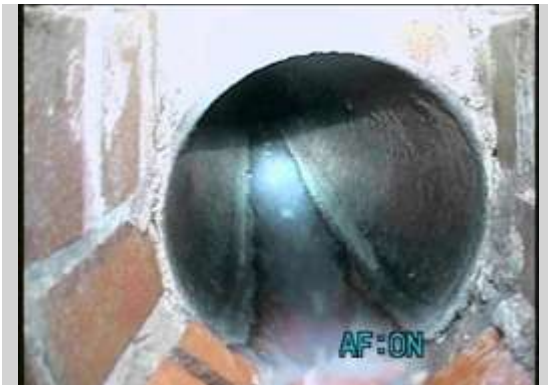
5 O'Clock Inflow

8 in. Circular Gravity Sewer  
Pipe In @ 5 O'Clock

Pipe Material: **Clay** ☐ Pipe Lined

Invert Depth: 5.25 (ft.) Flow Characteristics: **Fast**

Infiltration: **None** Pipe Seal Cond: **Unknown**
